RESEARCH ARTICLE

Urban Green Space Rehabilitation in Campo Grande, MS. An Overview of the Anhandui River Current Situation, Post Revitalization Project

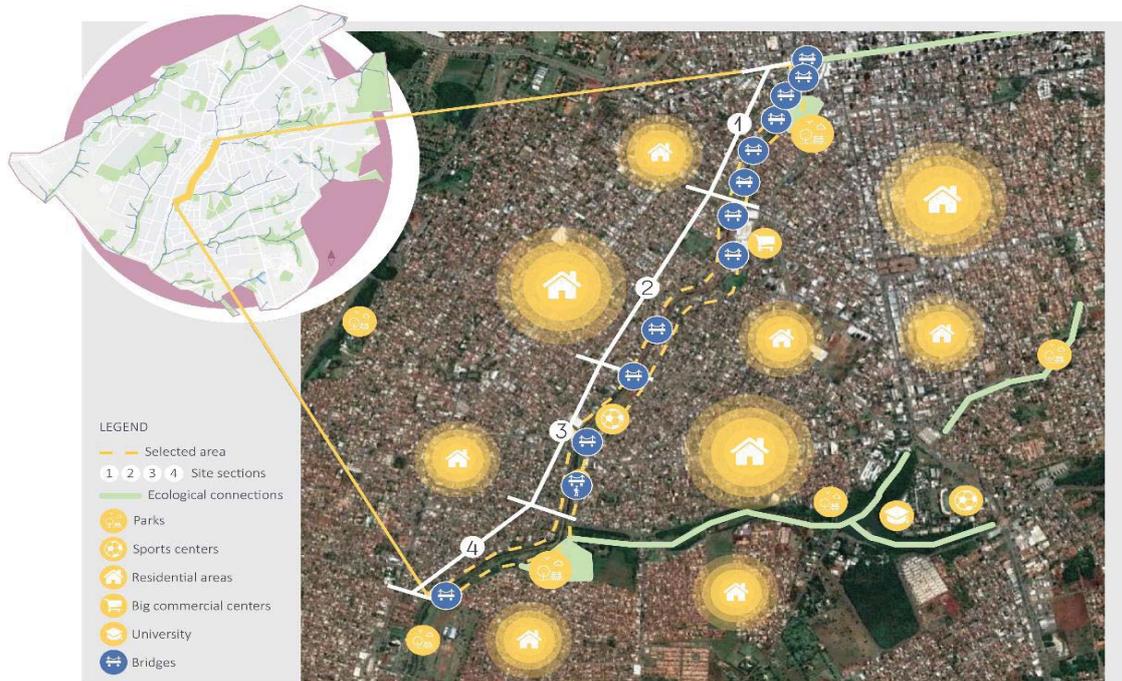
Figure 1 Research site in Campo Grande (Image by Camila Rosa/Reproduction: Google Maps).

January 2019, utilizing a field assessment form elaborated by the academic. Due to the length and different profile of the selected area, the site was divided into four sections (Figure 1), together with the urban context it is inserted. Afterwards, those sections were subdivided according to the number of bridges and character it presented, leading to a total of twelve subsections, envisioning the facilitation of data collection and assessment.

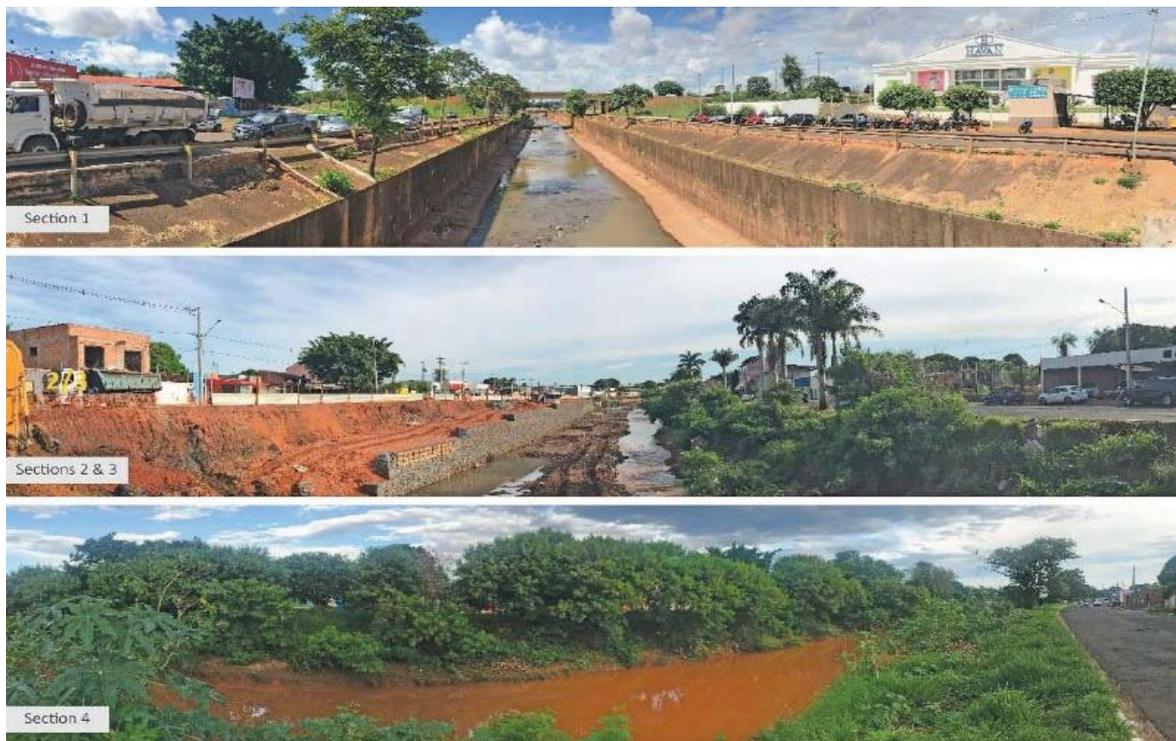
Figure 2 Study site overall character changes by sections (Image by Camila Rosa).

At this stage, resulting from the site assessment it can be stated that the profile starts with predominantly man-made structure resulting in an approximately 90% artificial character in section one, due to the concrete engineering structure covering the entirety of the river bottom, bed and most of the riparian zone, whereas section two is approximately divided in a 60% - 40% ratio of man-made and natural surfaces. On the other hand, section three could be described as 85% natural and section four as having approximately 95% natural, containing only a few old concrete small retaining walls hidden among the vegetation, besides the steel concrete structures underneath the bridges. Even though these proportions were not calculated with specific mathematic formulas, the overall conclusion is that in a Southwest direction, the artificiality of the river decreases, meaning that the closer to the city centre, the more artificial the character gets, in contrast to the naturality still existing in opposite direction (Figure 2).

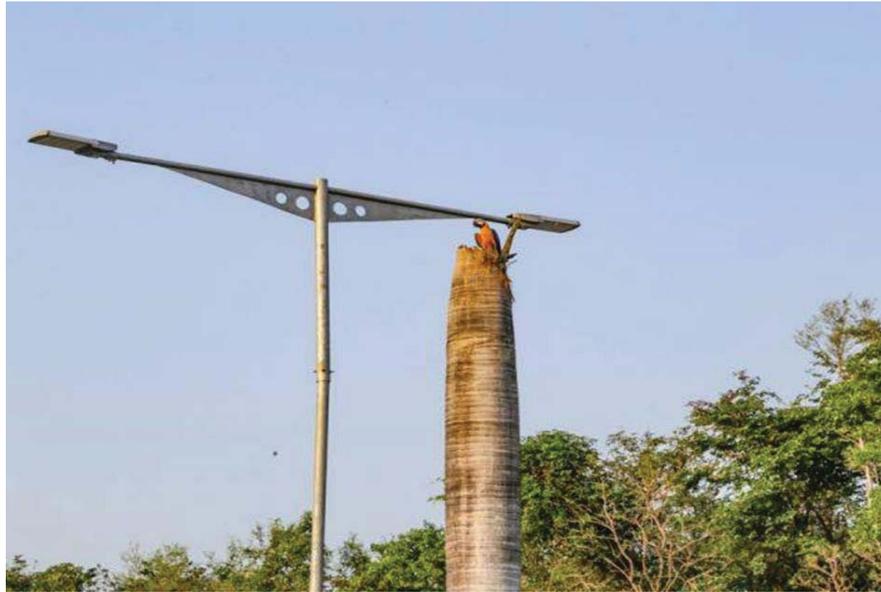
Figure 4 Macaws take advantage of the hollow space of the palm tree for housing (Photo by Kísie Ainoã, retrieved from <https://www.campograndenews.com.br/meio-ambiente/um-ano-apos-serem-replantadas-palmeiras-apodrecem-em-avenidas> on 13 May 2021).

death and deterioration are probably associated with the transplantation from the river shore to their new location [24].
